# Case Study Ventura

P&O Cruises Ventura underwent a major refit in Monfalcone, Italy. Launched in 2008, the cruise ship is one of the largest of the P&O ships carrying over 3,000 passengers.

<b>Name:</b>	Ventura
<b>Location:</b>	Dry dock
<b>Project Type:</b>	Stage refurbishment
<b>Building Type:</b>	Cruise ship vessel
<b>Product Types:</b>	Harlequin Cascade, Harlequin Marine

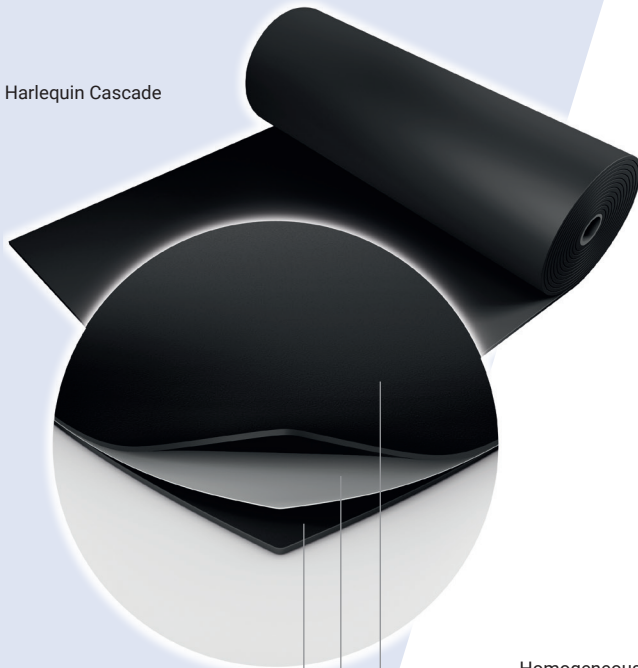
Homogeneous PVC with a slip-resistant dance surface

Mineral fibre reinforcement

Homogeneous PVC

Harlequin Cascade vinyl flooring was installed to the plywood sub-floor of the main stage and cut to fit around Serapid tracks, traps and stage lifts.

Harlequin Cascade was installed onto the plywood surface of the fixed stage area and revolve stage extension of the Explorer Lounge.

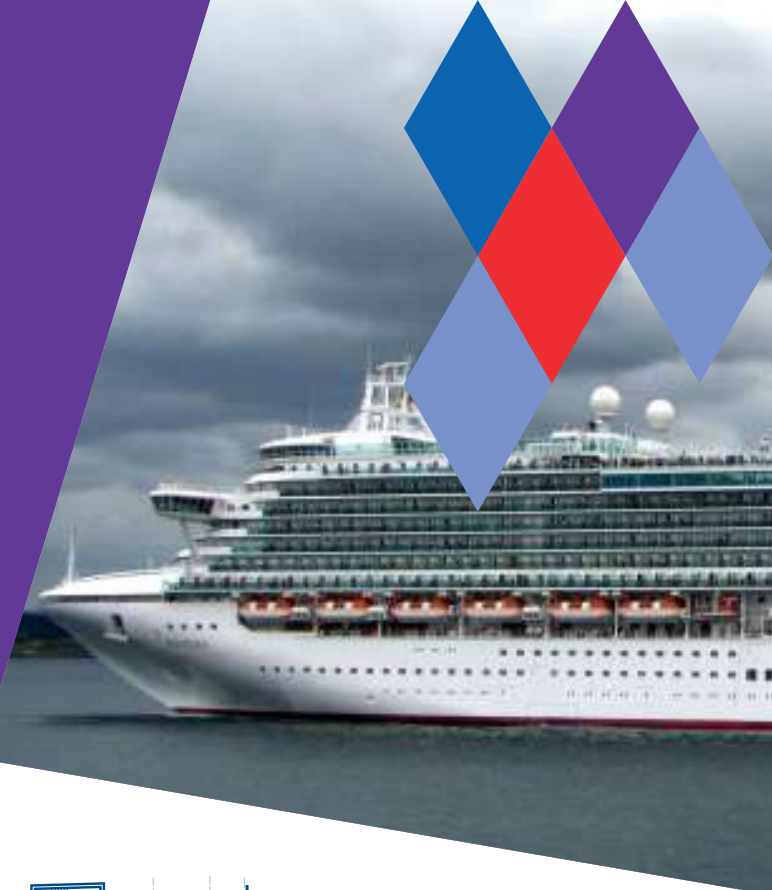
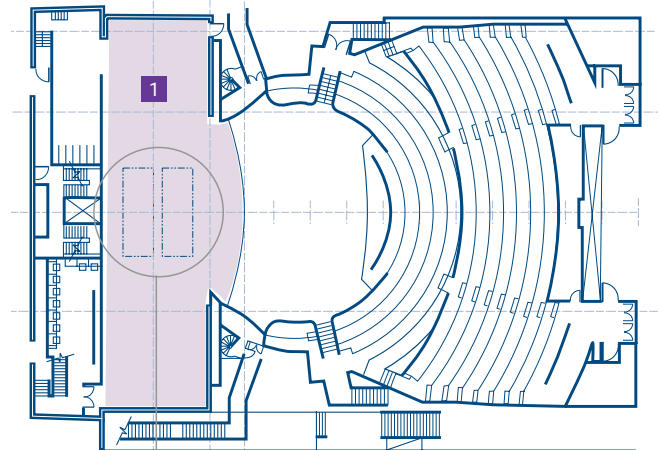
- 1 Main Stage: 265m<sup>2</sup>**
- 2 Scenery Store: 109m<sup>2</sup>**
- 3 Explorer Lounge: 168m<sup>2</sup>**

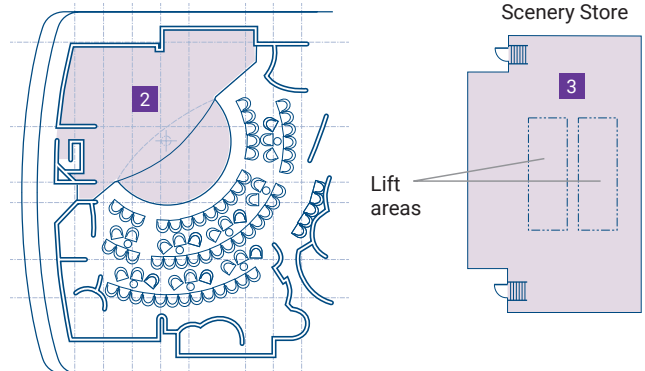
Cross section of below stage storage area with stage lifts

A special screed was laid directly onto the metal deck immediately below the main stage and Harlequin Marine was installed onto the screeded area, including the surface of the stage lifts.
